Field report from the journey to North-East Greenland 2017

Viva Villaen!

Field report for the "Villa team" 2017

Field report for the "Daneborg team" 2017

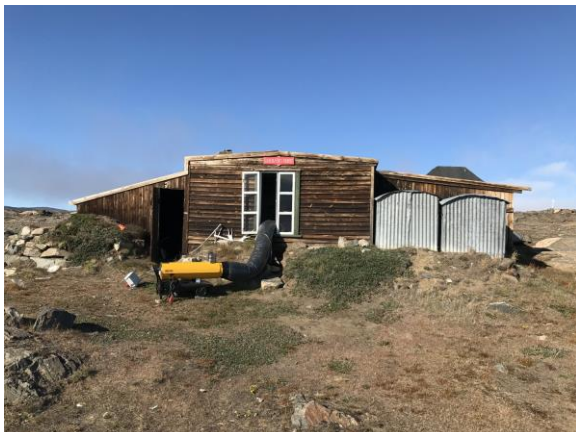
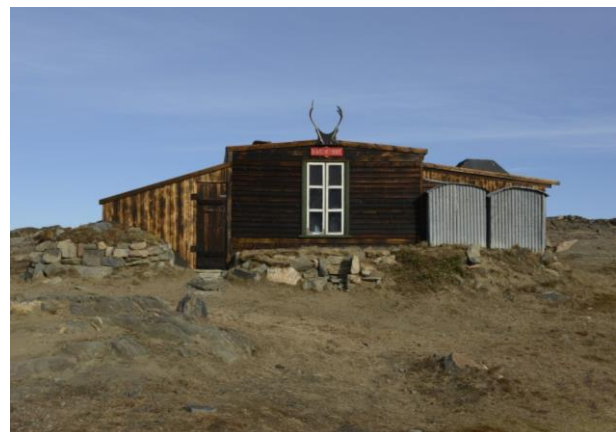
Villaen before and after restoration. The facade seen from South.

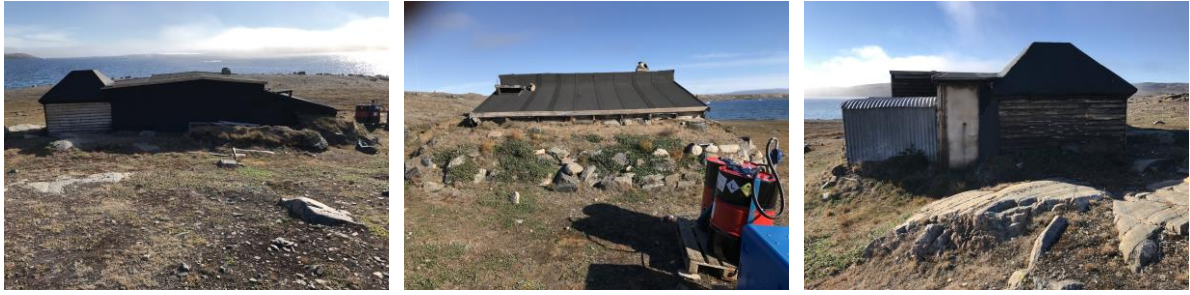
Villaen before restoration. Seen from North, West and East.

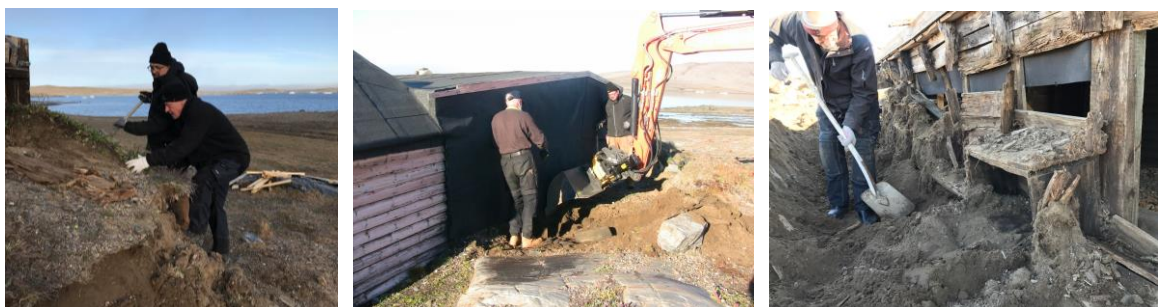
The bank during excavation. Left: Stone and peat are removed carefully by hand. Middle: Precision work removing earth with excavator. Right: Carefully moving the earth, which is examined for old, historical things.

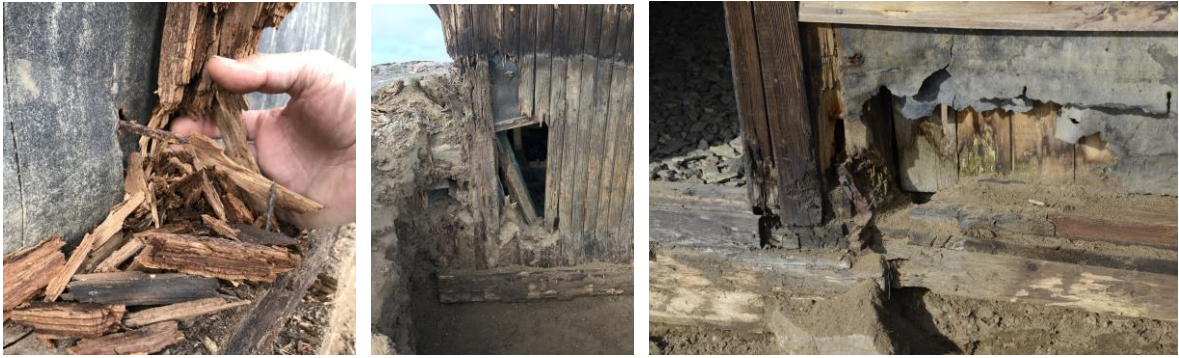
The excavation along the walls revealed more and more rotten wood, which practically disintegrated between our fingers.

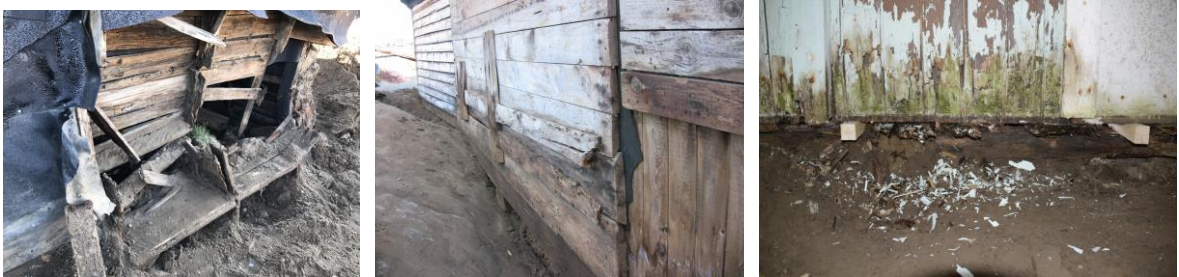
There were rot and decay in the lower areas of the walls.

We exposed the posts up to 40 cm height and, after removing rusty nails and rotten wood, installed new pieces of timber in the construction to replace the wood that in some places crumbled between our fingers. Everywhere in the inner room, the vertical wall sheathing was in a very bad state due to rot, and we fixed plywood inside the wall to support it during later attachment of skirting boards.

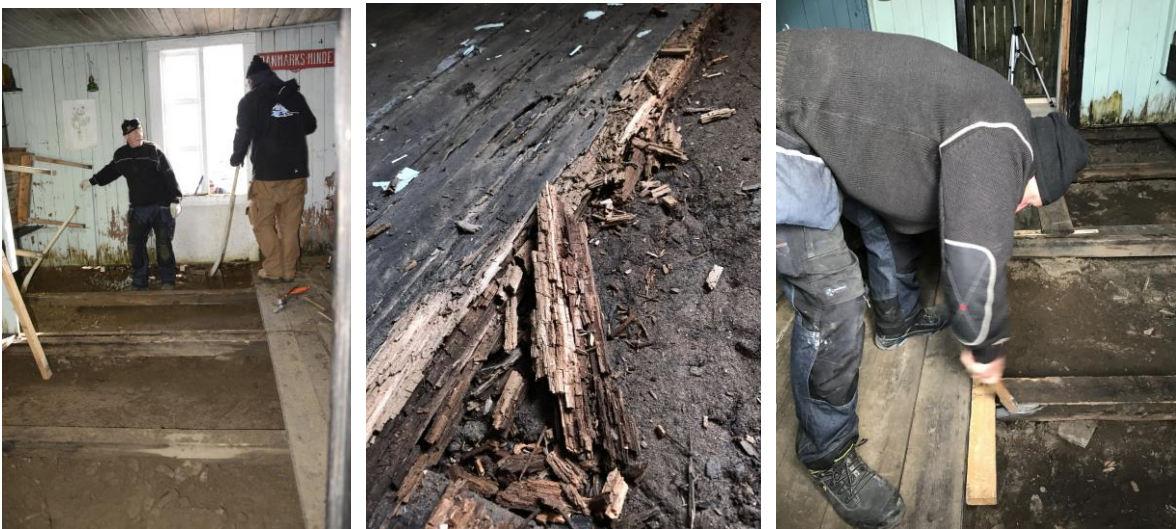
The joists are exposed, where the floor has been broken up. Many boards disintegrate.

Unfortunately, the many years with water ingress, virtually since the beginning, had caused so much rot in the woodwork that it only with great difficulty was possible to retain a little more than half the old floorboards. After exposing the joists, all functional boards were reused and the rest replaced with new, solid pinewood boards.

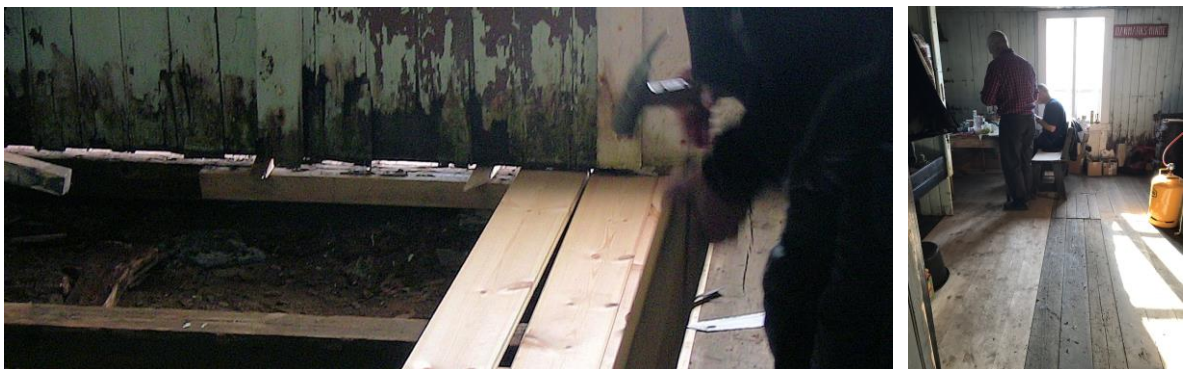
Left: The floor continues under the wall. Right: Finished floor.

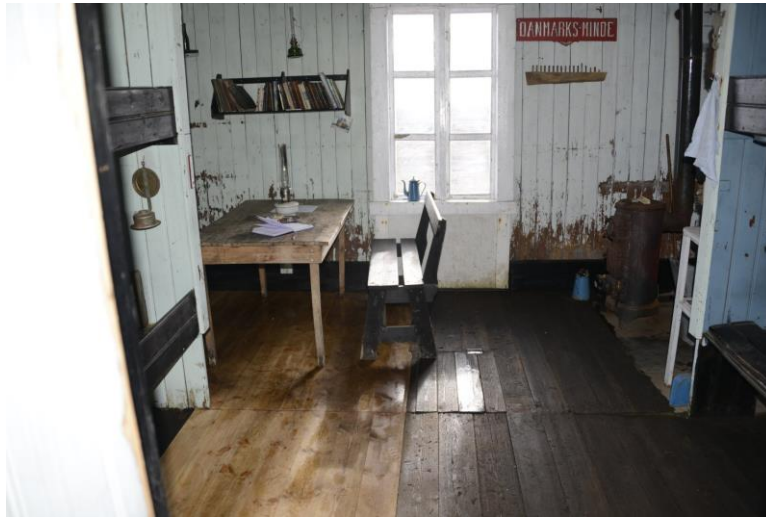
Left: Finished floor and skirting boards. Right: Drain from the floor is led through the bank.

The finished floor was completed with new, broad skirting boards, which were painted black just like the existing door frame and architraves.

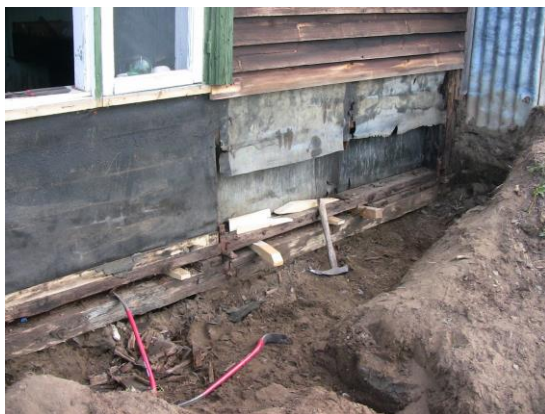
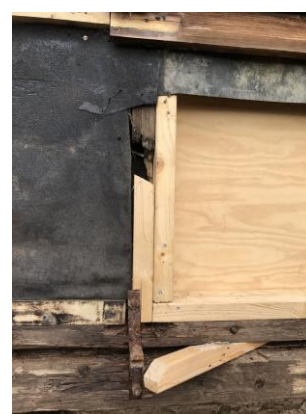
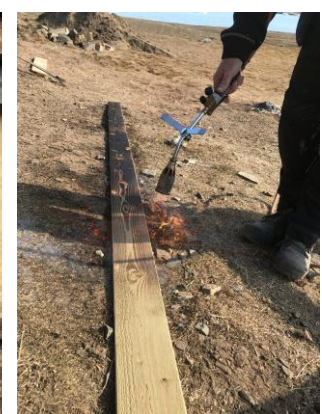
Left and middle: The rotten posts below the window. Right: The new wood is scorched with a gas burner to give it an authentic appearance.

Roofing felt and new clinker sheathing were attached. To give the appearance of old wood, we scorched the surface with a gas burner. The advantage of this treatment is that it closes the pits in the surface, thereby prolonging the service life of the wood.

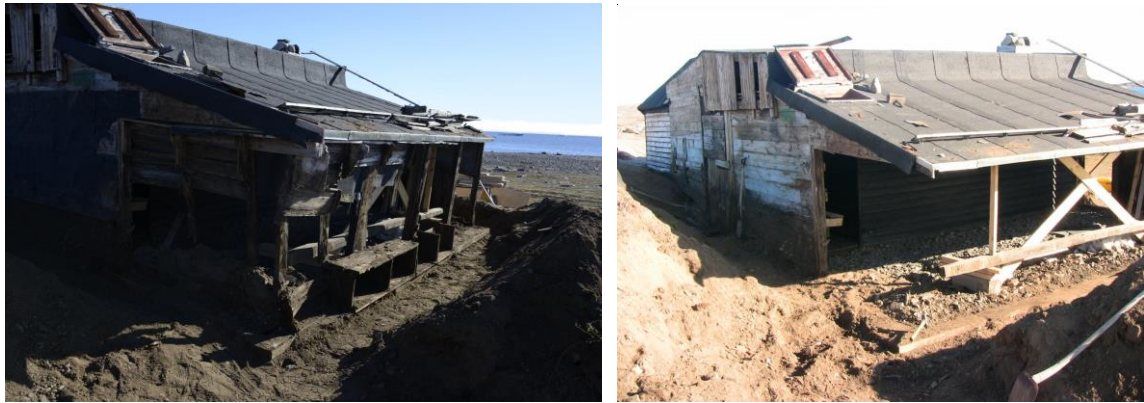
Left: The boxes in the bank. Right: Roof is supported

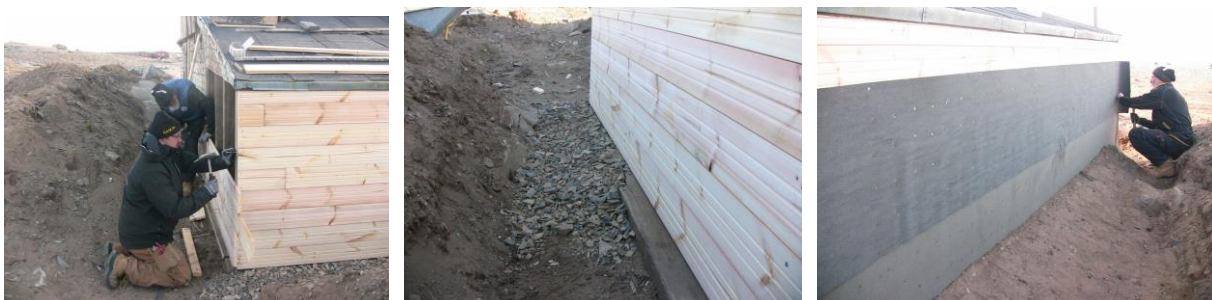
The new wall with floorboards, drain made with chippings and roofing felt.

Along the wall we made a drain from chippings, adding a layer of inner roofing felt in the bottom and outer roofing felt on the top. We burned on outer roofing felt in vertical bays, put on a layer of earth and then another layer of felt to lead away the water, from the wall. On top we made a new bank.

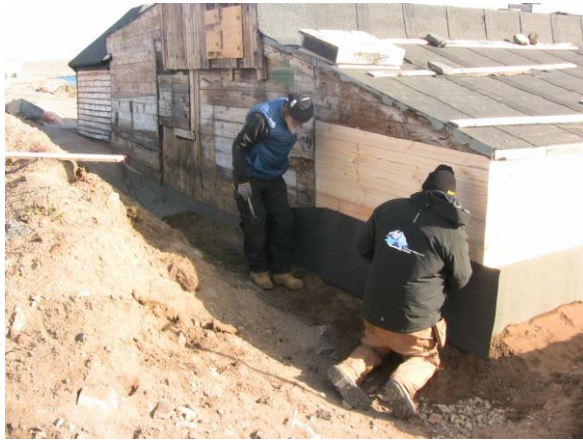
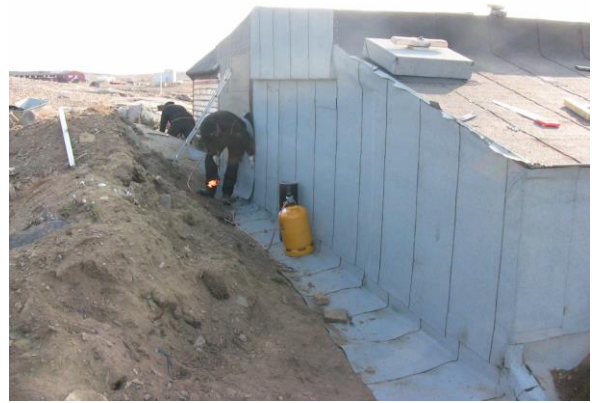
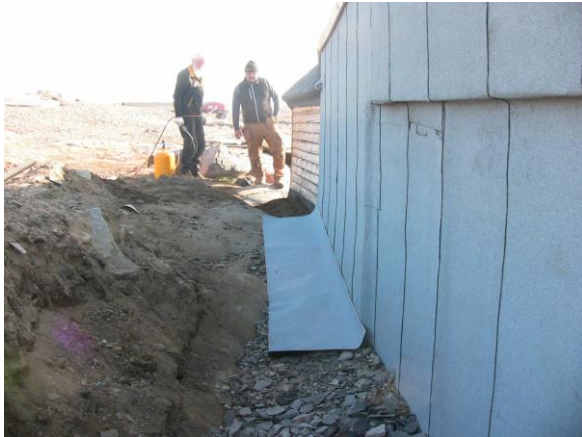
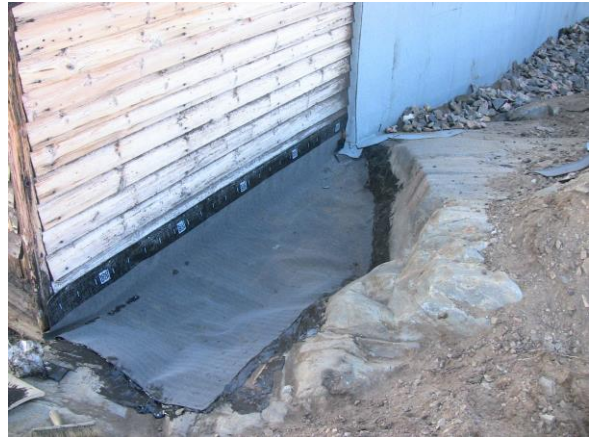
The first 250 cm of the wall toward west had the same overhaul as the west wall. Here there was a depression in the bank, and

Restoration of the north wall.

meltwater from the north slope had had easy access into the porch. We exposed the rest of the wall down to the bedrock and in some places in the porch deeper in. The boards came in many different sizes of questionable quality. Similarly, it was a chaos of angles and additions, so we had to remove all the roofing felt to thoroughly renovate the wall. We nailed on new inner roofing felt and let it cover 70 cm from the wall toward the subsoil. We put rocks of the size of fists on top and then chippings. Over these we again let the outer roofing felt cover approx. 70 cm outward. Asphalt primer was applied to the

rock in the places it had been exposed, and the felt was welded directly on. A stone construction and earth bank were established on top of the foundation of stone.

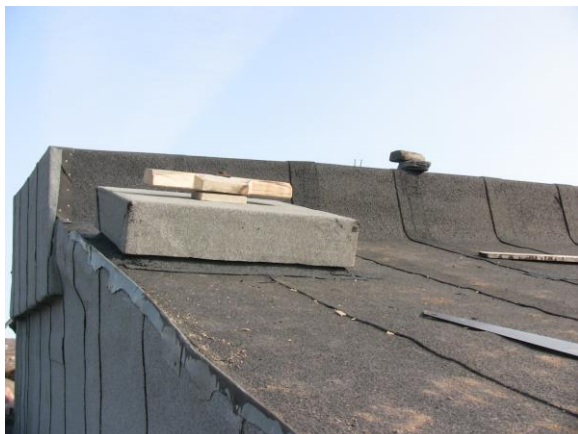
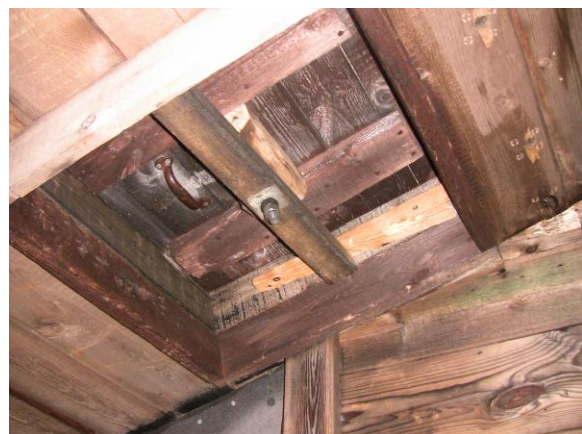
The trapdoor to the attic.

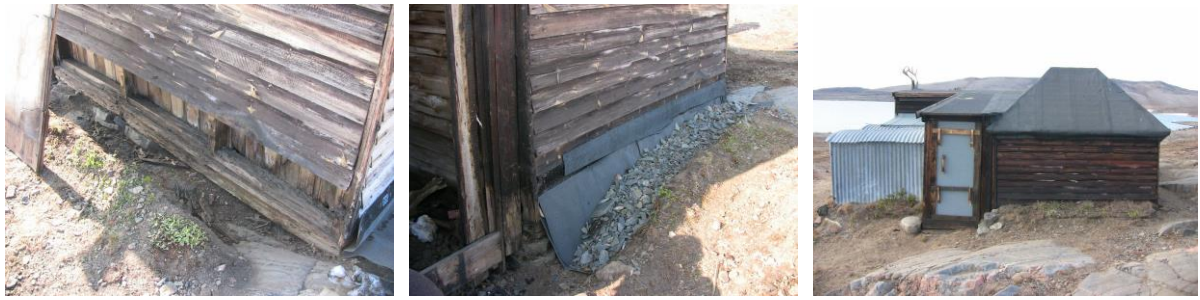
Left and middle: East wall before and after restoration. Right: Finished wall with backdoor.

The door from the hallway and out into the open was restored and became useable again. Now it can be opened from the outside and closed with two horizontal bars that help keeping the door in place. We did a total restoration of the wall around the door, which was very draughty.

The east wall was dug free, and here the sill and the lowest 25 cm of the posts were in a very bad state. New timber was laid in, and we isolated with felt before attaching new clinker boards. The earth bank was re-established with a drain made with chippings. Outside, inner roofing felt was nailed on, and a piece of outer roofing felt was burned on to finish.

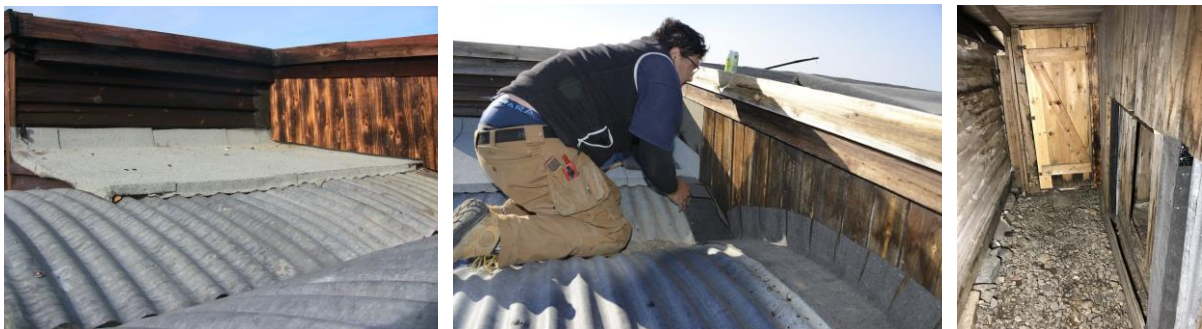
Left and middle: Roof over containers. Right: The hallway and opening into the containers.

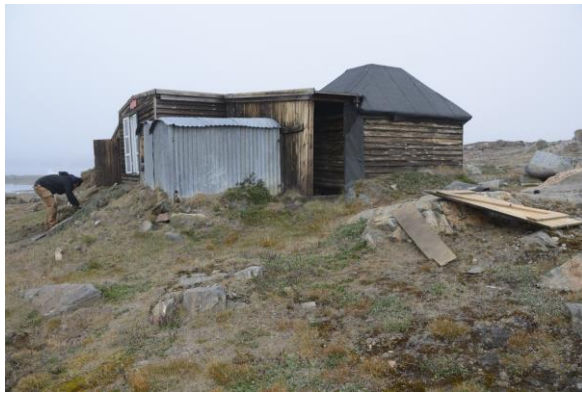
The house and the earth bank before (left) and after.

However, a foot deeper toward the wall, it was still very damp. Since the water has had direct passage from the roof, particularly the westernmost part of the bank was damp, consisting more of sand than earth. Without any protection against water on the porch, as mentioned, the rest of the water had been penetrating the passage and the floor further inside the house.

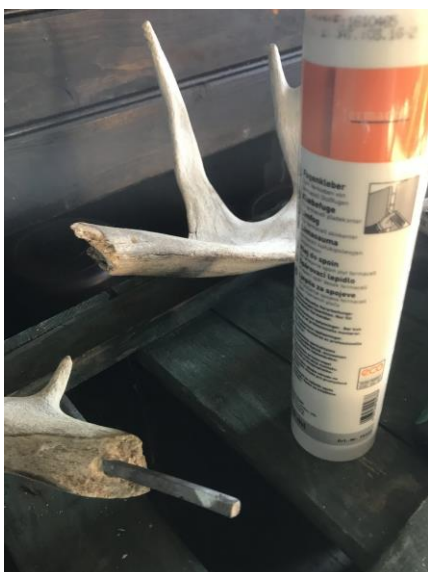
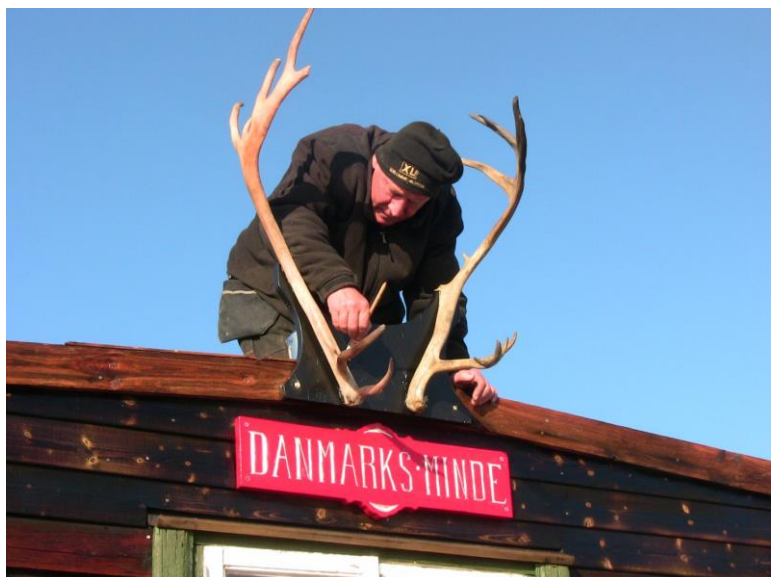
The antlers are repaired and mounted.

mounted to the end wall in an old photo of Villaen from 1907, were found scattered on the ground outside. They were repaired and remounted.

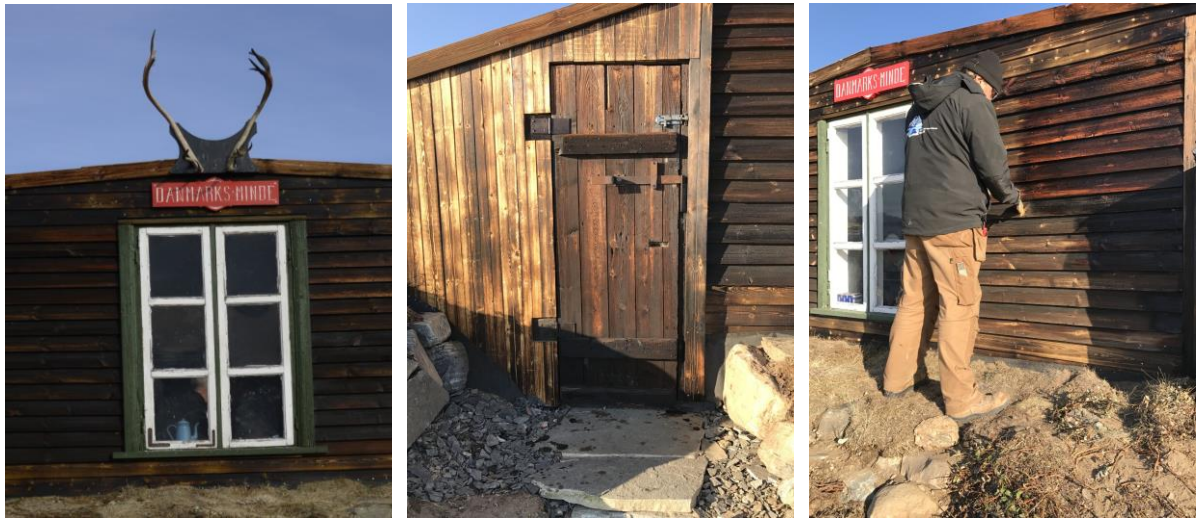
Left: Thw window. Middle: Front door. Right. The final painting.

The window in the façade was in good condition. We installed some angles, which we found in the gravel, and the handles were strengthened, tightening the window. Then putty and linseed oil primer were applied.

The front door received a much-needed lift. The surface of the door was reinforced; rot was removed from holes, and a new hand-forged door handle has mounted, so now the door can also be closed from the inside. The frame was reinforced, and rotten parts of the lower part of the door were replaced.

All outdoor woodwork was treated with a linseed oil primer. In accordance with recommendations from the Greenland National Museum, indoor surfaces and interior were left without painting to keep the authentic appearance.

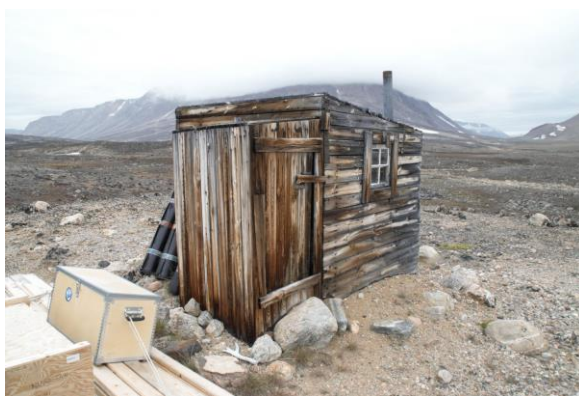
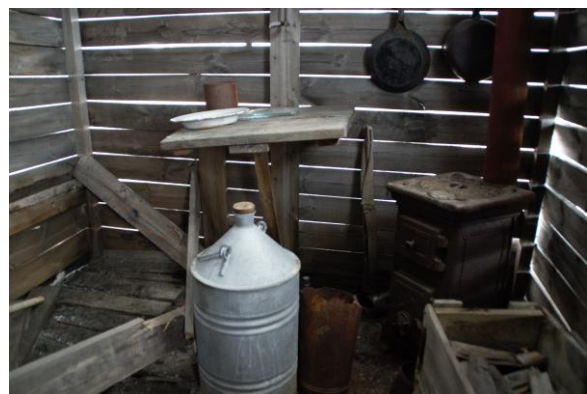
Blæsenborg [443] upon arrival. Materials for restoring the hut had been delivered at the hut beforehand, in May-June, on snow scooters by the Zackenberg Zero people.

It was grey and windy when we arrived, so there was no reason for sitting down and get lost in our own thoughts. The hut was emptied, and the earth cleared all the way around. The lower boards on three of the sides were replaced, as well as a part of a corner post. The floor lay directly on the ground and was, sadly, rotten to the core. We removed it and dug out earth before laying new joists and floorboards, with air between wood and earth. Bisse was the indoor man, and the floor was ready at midnight. Sebastian and I took on the roofing felt outside. We were a little unlucky with the weather, as it started to snow at 8 p.m. The temperature was about zero, and we got a little wet, but not enough to drown the spirits. We put inner roofing felt loosely on the roof, planning to sleep in the hut. We easily fit on the floor all three of us.

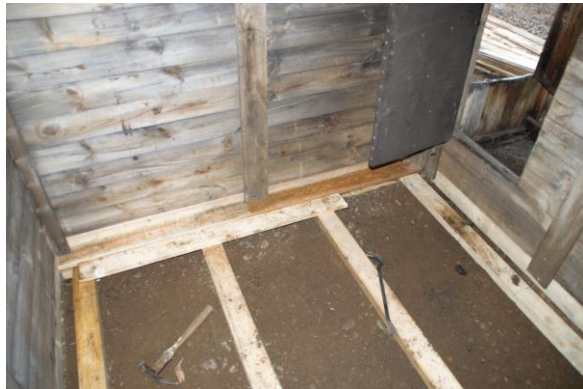
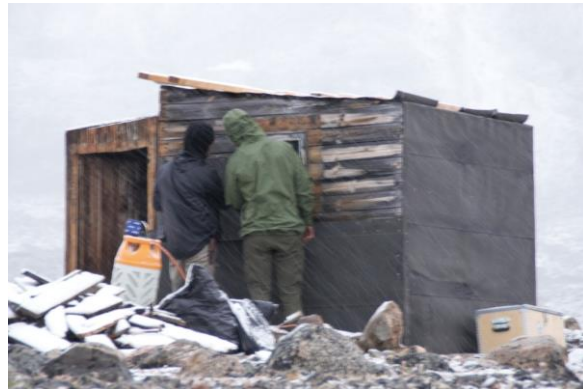
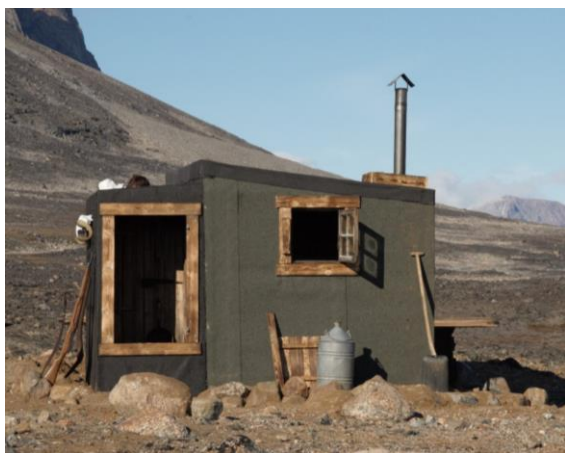
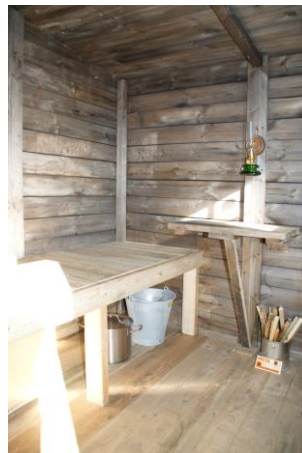
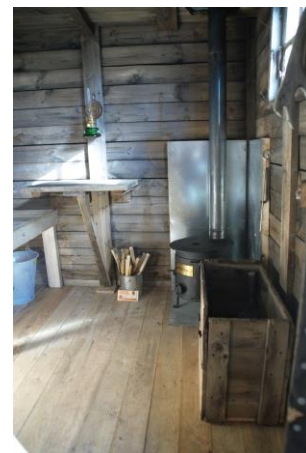
Restoration of Blæsenborg [443]. The old floor was rotten and had to be replaced. A new bunk and table similar to the previous were made for the inside.

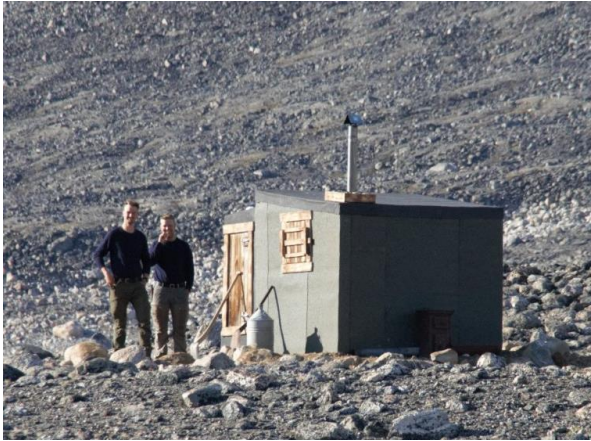
Left: Job done, Blæsenborg! Right: Three happy Nanok'ers. From the left: Tobias Daugaard-Petersen, Brian Nissen and Sebastian Bøg Kolind.

easily. As there, by coincidence, had been delivered both black and green outer roofing felt to the hut, the sides became green, and roof and porch black. New roofing around door and window, which also got a new layer of putty; shutter and stone box for the stovepipe were made and burnt just enough to make them look like the original. Inside, a new bunk was made as well as table similar to the previous. The hut was put in order, and the residual materials were placed behind the hut to be picked up next spring.

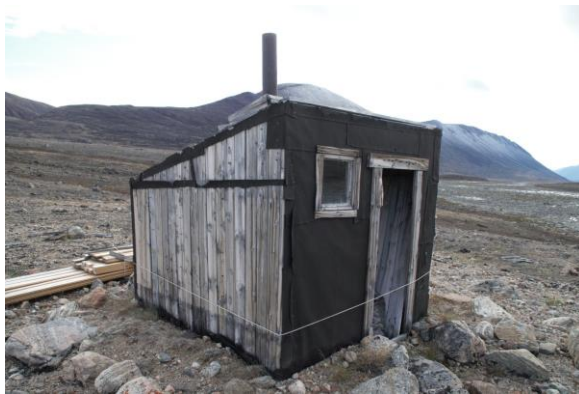
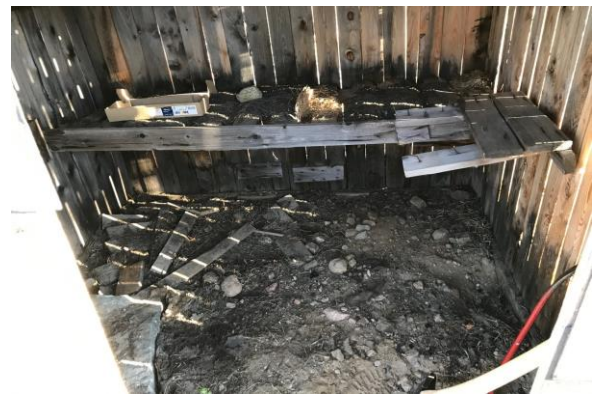
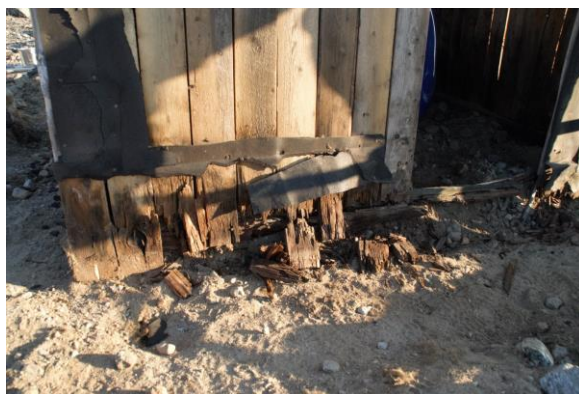
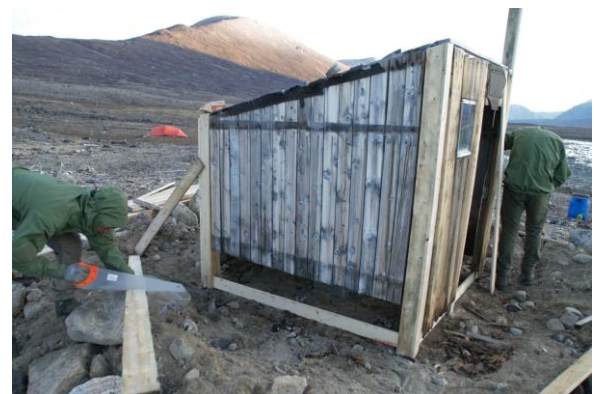
Restoration of Antonsens hytte [444] in Store Sødal. Top: The hut upon arrival. The bottom 15-30 cm of the walls were rotten. The boards in the corners and at the door were replaced to be able to carry the weight of the hut.

The boards here were vertical, and, on closer inspection inside, it appeared that the bottom 15-30 cm were rotten. Since we did not have enough wood to replace all the boards in full length, we chose to change the boards in the corners and at the door. We put some rocks underneath the boards, so they could carry the hut, and thereby the rotten parts could be cut off all way around and exchanged with new. The hut was sheathed with roofing felt, and this time we were able to make it completely black, except one single green line on the back wall. The floor was made of earth and rock, the old stove standing on a flat rock of ½ m². We chose to put a wooden floor and reused the rock for the new stove.

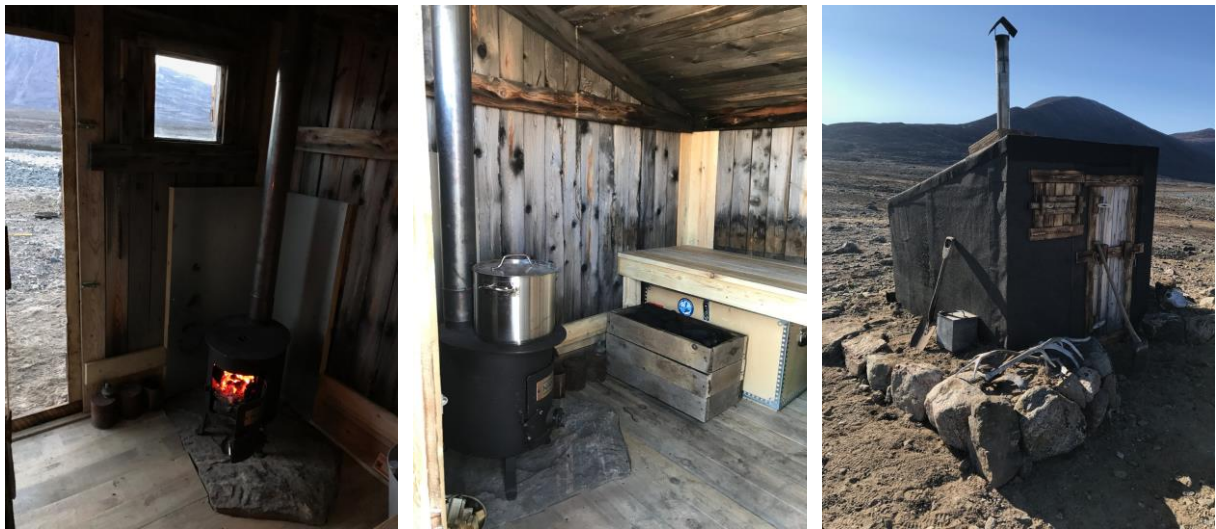
Antonsens hytte [444] after restoration. The old stove was located on a flat rock of ½ m², and the floor consisted of earth and rock. We chose to put a wooden floor, and the flat rock was reused for the new stove.

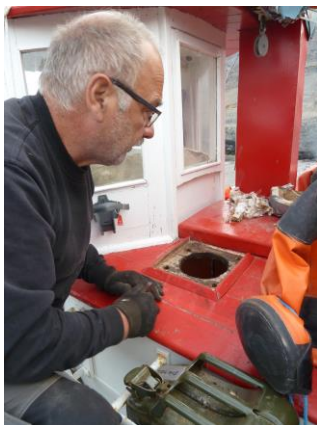
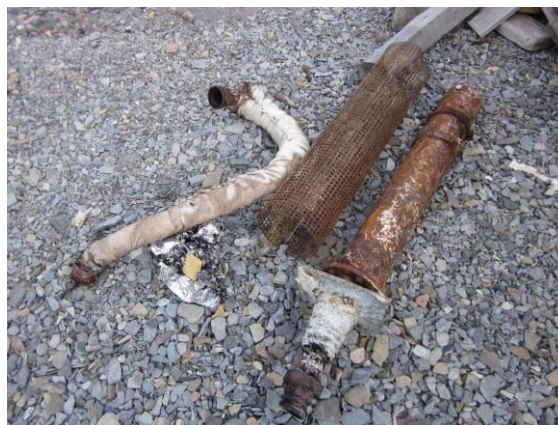
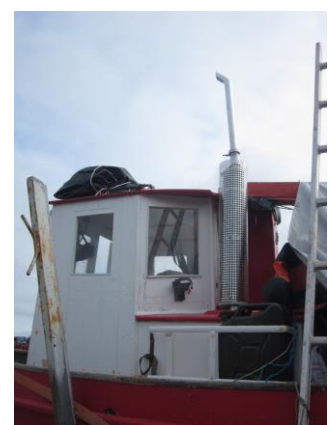
Left: Aage replaces the faulty exhaust pipe on "Agsut". Middle: The defective parts. Right: The new exhaust pipe mounted on "Agsut".

Back at Ella Ø, we started preparing for skibsmik, which among other things included packing various items that had to be shipped. Furthermore, we took off the rearmost tarpaulin of our dinghy "Agsut", which needed a replacement of exhaust pipe and fuel pump. This work started next day, 13 August, where we also recorded Street View photos of Ørnereden.

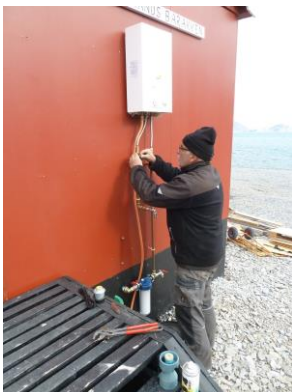
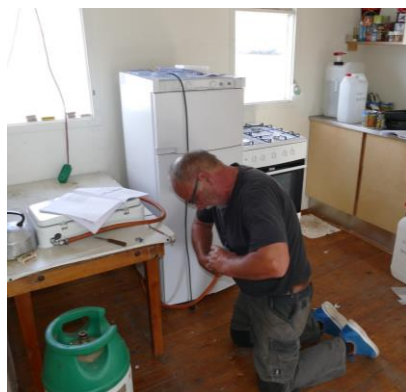
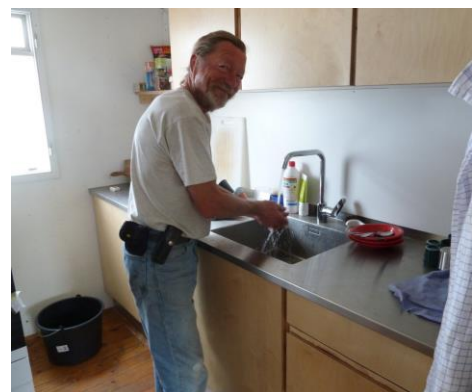
Left: Installation of water heater for Tolvmandsbarakken. Middle: Fitting of refrigerator and stove. Right: Running hot and cold water makes kitchen work much easier.

In the morning of 15 August, we started setting up water supply for Tolvmandsbarakken, so that both cold and hot running water can be drawn in the kitchen from now on. A gas stove and a gas refrigerator were installed inside, as well as new tables and shelving units in all rooms. The weather was quite calm and sunny in the afternoon, but about 3 p.m. a really heavy storm suddenly came in over the station. The storm continued without easing off until late

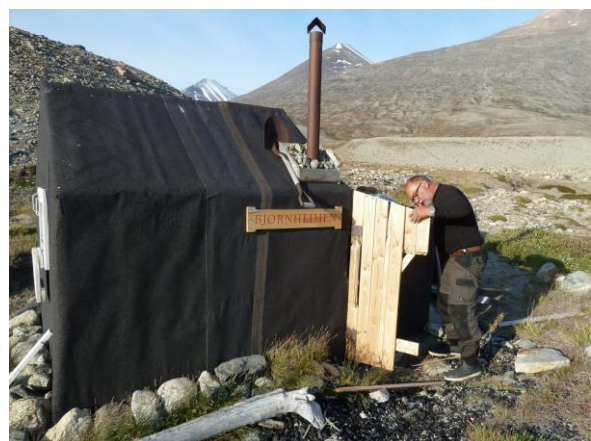
Left: Evening at Noa SØ Hytten [322]. Right: Repairation of the door on Bjørnheimen [310].

Next day, Tuesday, 22 August, we set off from Blomsterbugten at 8 a.m., just as the “Ocean Atlantic” with Quark Expedition was anchoring to visit the hut. Our first stop was Bjørnheimen [310], where we repaired the door and the table. Then we continued through Antarctic Sund, initially in sunny weather and dead calm sea, which gradually changed to strong headwind and sea, bouncing us around, until we arrived safely at Namdalshytten [305] about lunchtime. Here we made a new window shutter, as the old had been destroyed. Finally we set course toward Ella Ø via a quick stop at Maria Ø. At the same time as we called at Ella Ø, “Jytte” and her crew arrived back

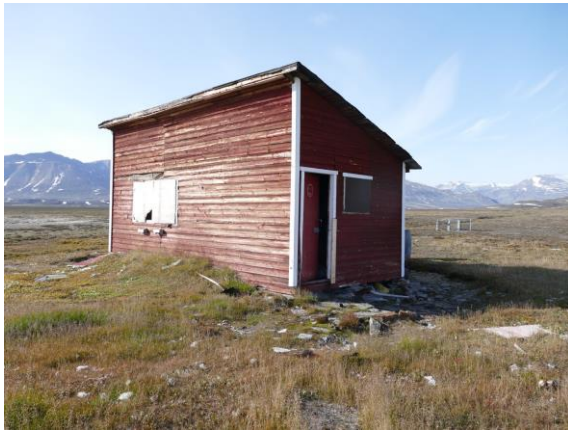
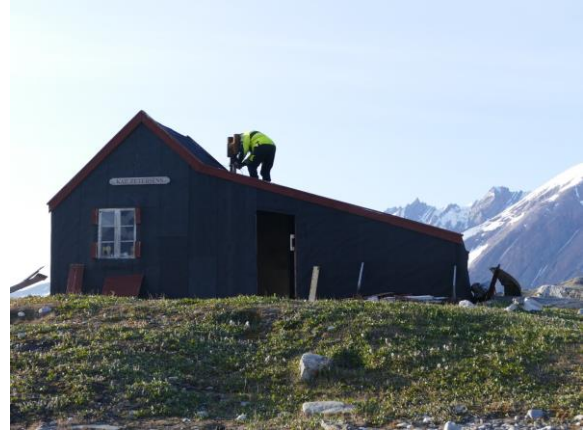
Left: Hamna [208-2] needs a thorough restoration both outside and inside. Nanok has scheduled this for 2020. Right: Replacement of defect H-piece on Kap Peterséns [218].

The morning after at 7, we launched from Nyhavn to return to Ella Ø. En route we visited the station Kap Peterséns, where we replaced the defective T-piece on the stovepipe. From there the journey continued to Ella Ø in mixed sailing weather, varying from completely dead calm in the east of Narhvalsund to foaming heavy seas and wind around Bastionen. Nonetheless, we arrived safely at Ella Ø at 11:30 a.m. in a bright sunny and windy weather. At high tide later that afternoon, we docked Brebøljollen and thereby concluded a fine sailing season for the Ella Ø team.

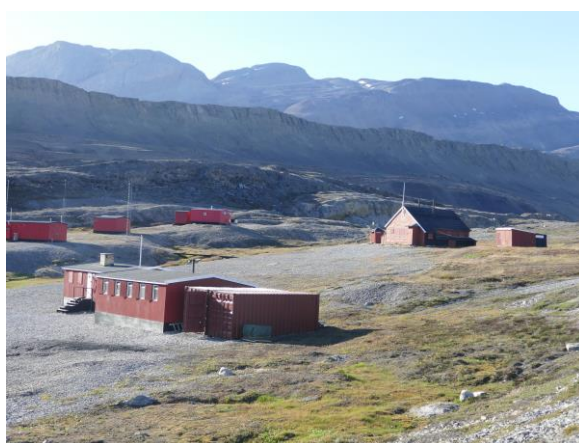
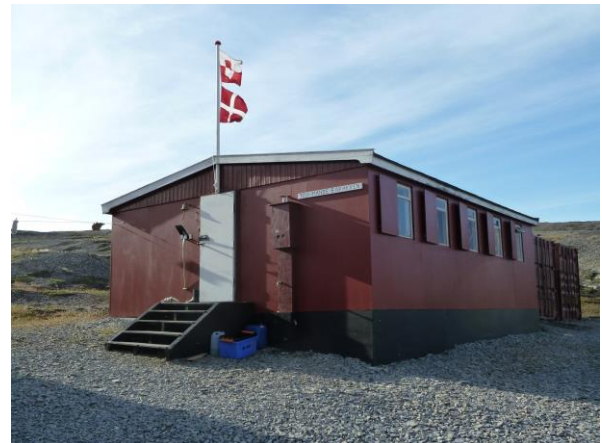
Left: Ella Ø with Tolvmandsbarakken and the two Nanok containers in the foreground. Right: Tolvmandsbarakken before departure. It has become a lovely expedition house.
